DE BEERS GAHCHO KUÉ MINE NHX on-the-land meeting September 26, 2017

2017 MINE UPDATE

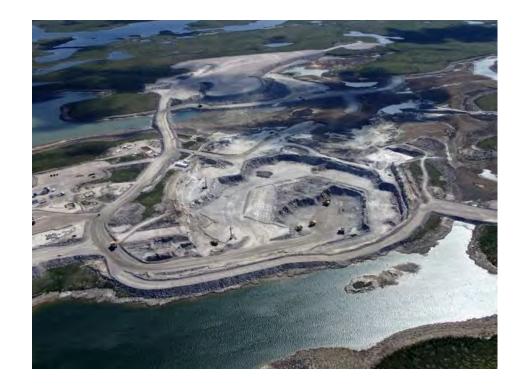
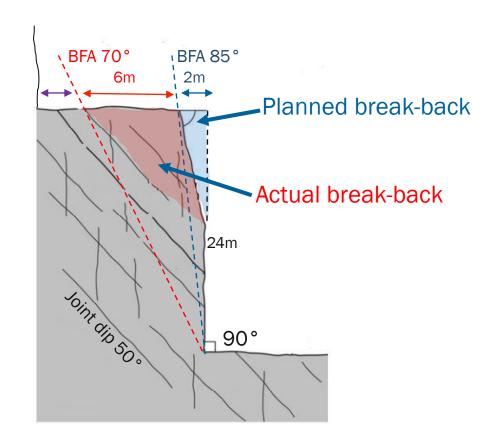
5034 Pit - East wall

- 5034 Pit has 'joint sets' on the eastern wall
- A joint is a break (fracture) of natural origin in the continuity of either a layer or body
 of rock that lacks any visible or measurable movement parallel to the surface (plane)
 of the fracture
- A **joint set** is a family of parallel, evenly spaced joints that can be identified through mapping and analysis of the orientations, spacing, and physical properties
- When joint sets are blasted, the blast pattern is affected by the joints, therefore changing the way the rock breaks.
- Rock is not breaking cleanly along vertical blast lines, but is breaking up also along the joint lines.
- Issue extends to Tuzo and Hearne
- Result is a reduction of the catch benches leading to a safety issue for our workers below

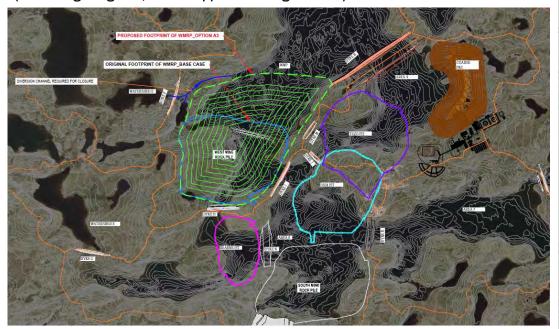
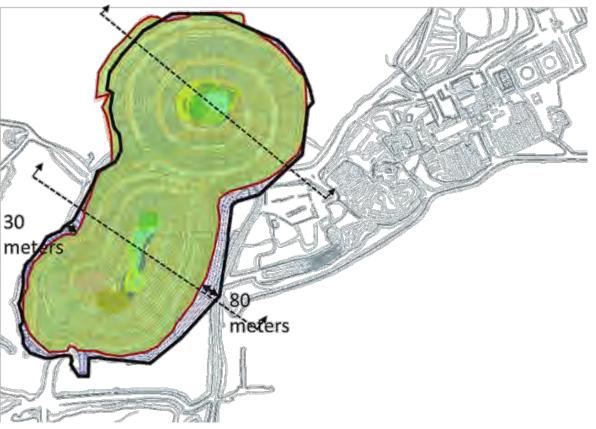
Proposed location of additional mine rock on the west mine rock pile (new design in green, former approved design in blue)

- Joint sets at 5034 Pit, Tuzo, and Hearne pits necessitate pit expansions and the extraction of up to 100Mt of additional mine rock
- A water license amendment is required prior to placement of the waste rock
- Analysis of placement options and timing considerations completed, decision to place rock on northern side of west mine rock pile
- Engagement has been conducted with regulators, communities regarding design options for the west mine rock pile

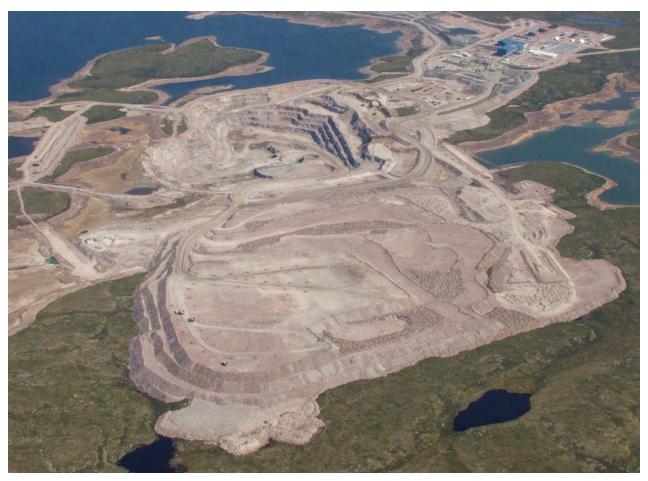
Foreground: South Mine Rock Pile in development; Background: 5034 Pit and Mine Site
